A Project to Correct Mill Power Factor

Selection and Deployment of a Second Capacitor Bank

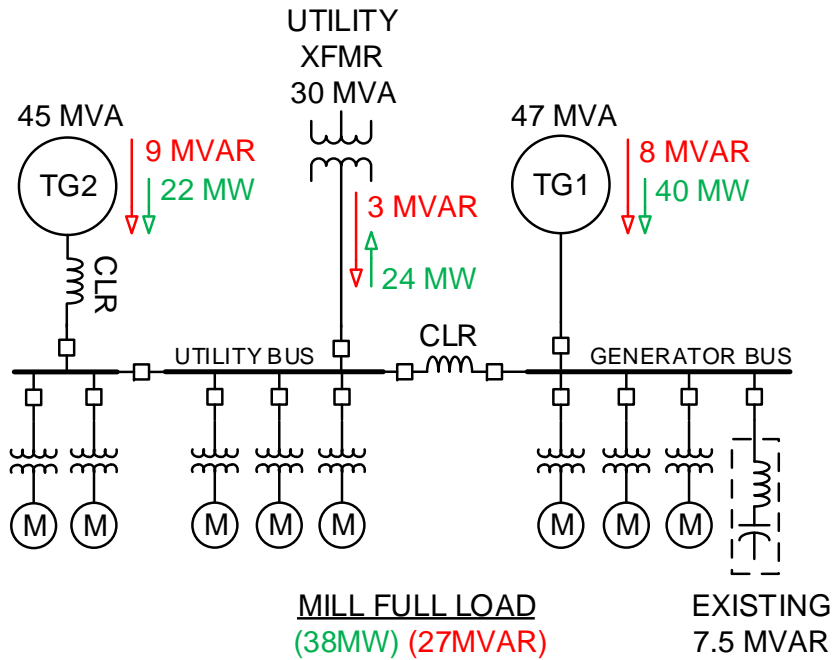
Existing Power Flow

- Utility Bus & Generator Bus operate at 13.8kV, with 2.4kV and 480V Secondary Subs
- Mill load at full production → 38 MW/27 MVAR
- Generators supply 17 MVAR reactive power to mill load
- Existing Capacitor Bank supplies 7.5 MVAR reactive power to the mill load
- The mill imports 3 MVAR from Utility
- TG1 provides process steam and is operated as a regulated unit (constant P & V)
- TG2 does not provide process steam and is operated as a condensing unit (constant P & Q)
- ISSUE: TG1 is operating at reactive limit with frequent trips due to overheating of the field

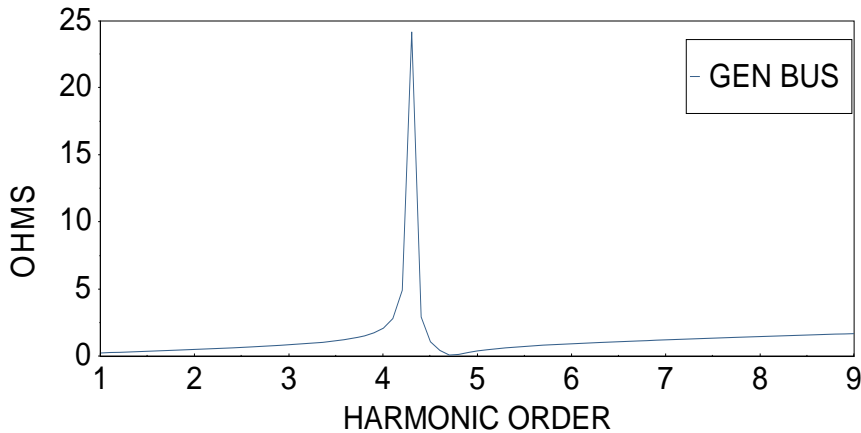
Harmonic Resonance

- IEEE 519-2014, *IEEE Recommended Practice and Requirements for Harmonic Control in Electric Power Systems*, New York, NY: IEEE.
- Existing cap bank on Generator Bus is tuned to filter 5th harmonic currents, tuning point H=4.8
- New cap bank on Utility Bus is designed to filter 7th harmonic currents, tuning point H=6.8

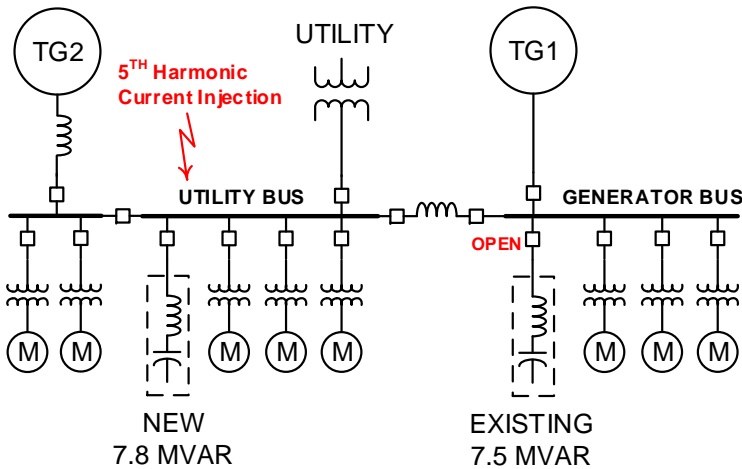
Harmonic Resonance

- Existing cap bank on Generator Bus is tuned to filter 5th harmonic currents, tuning point H=4.8
- New cap bank on Utility Bus is designed to filter 7th harmonic currents, tuning point H=6.8

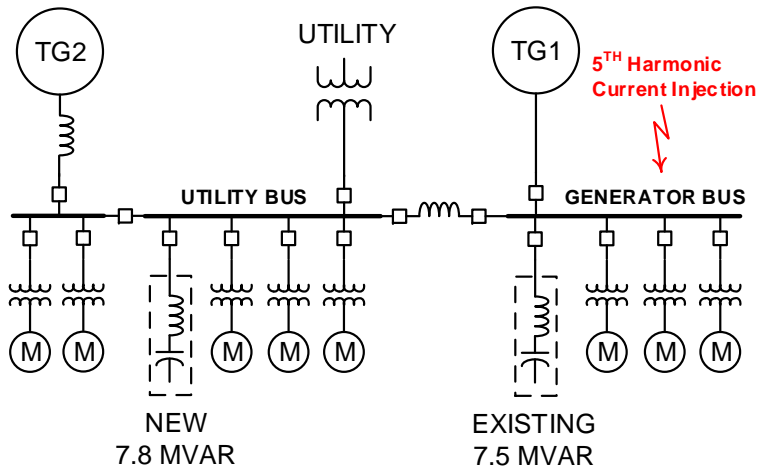
- Both cap banks in service, Mill at full production
- 5th harmonic current injected on the Generator Bus
- Again, the frequency response of the system shows two resonant points
- Resonant points are close to even harmonic orders

5 Amps X 0.5 Ohms = 2.5 Volts

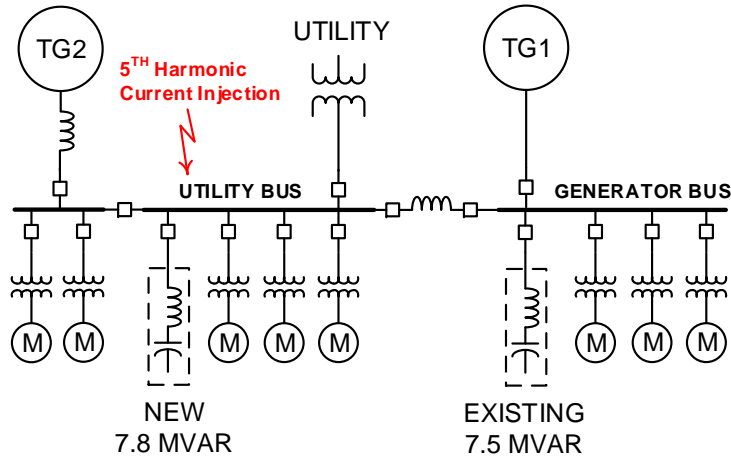
Harmonic Resonance

- Mill load is reduced to 50% for this simulation
- Resonant impedance increases in magnitude
- Resonant points shift closer to odd harmonic orders – Dangerous Condition!

5 Amps X 15 Ohms = 75 Volts!

Many simulations were required to develop capacitor bank switching procedure for Mill Startup & Shutdown operations

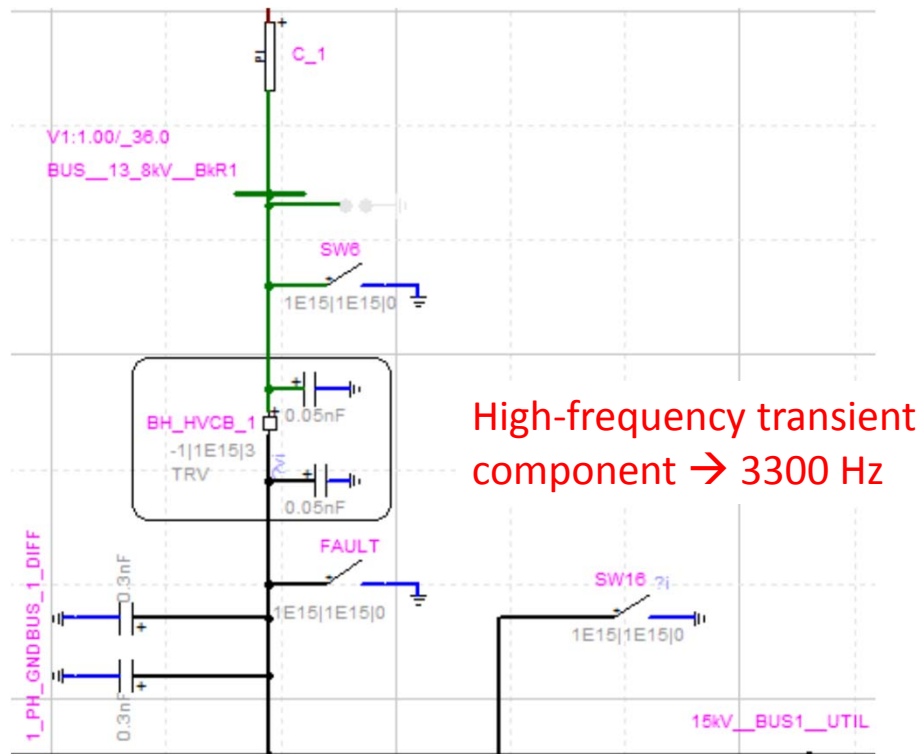
Circuit Breaker TRV

Inherent Voltage → voltage across circuit breaker when interrupting a fault

High-frequency transient component → 3300 Hz

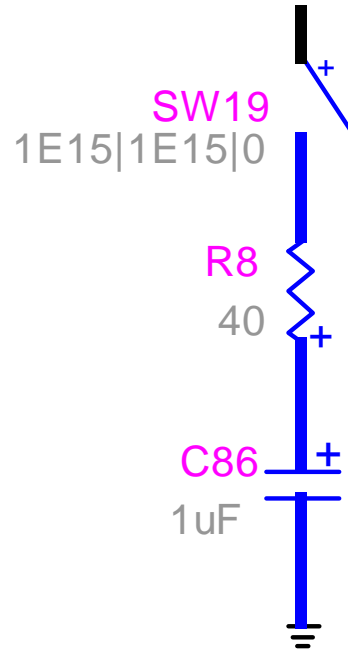
Circuit Breaker TRV

One solution to the TRV issue is to install RC Snubber at the Utility Transformer secondary

Snubber eliminates the high-frequency transient component of the Inherent Voltage

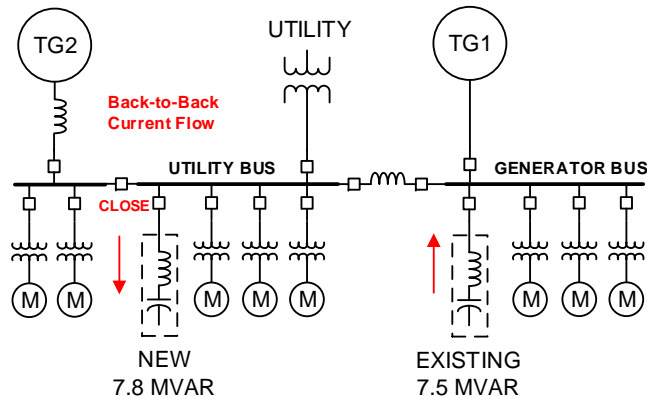
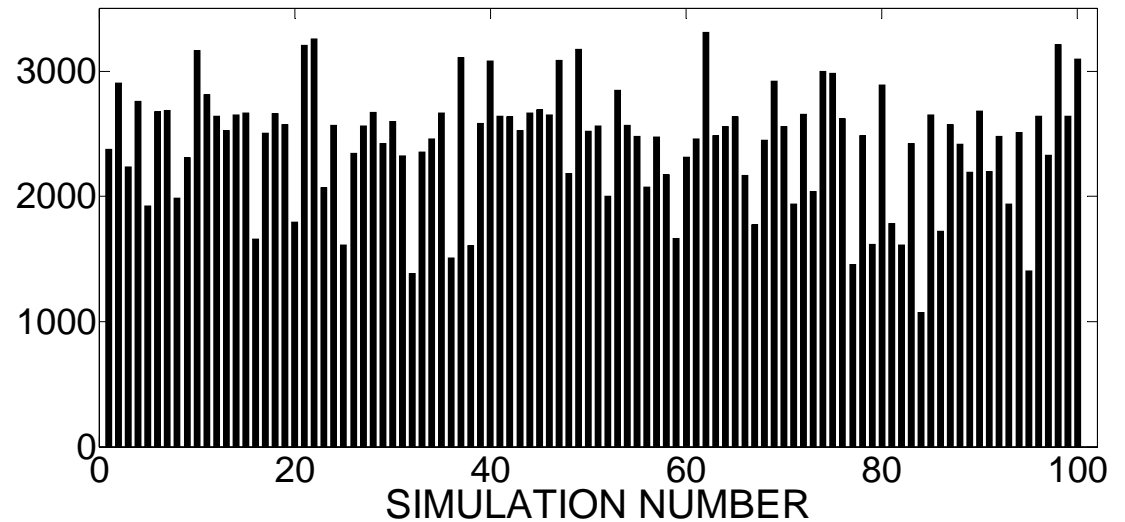
Back-to-Back Switching Current

Table 4 in IEEE Standard C37.06-2009 offers preferred ratings and required capabilities for Class S1 circuit breakers when used for switching capacitor banks (Current & Frequency).

Worst-case back-to-back current depends on where the first pole-to-close closes on the voltage waveform. A Statistical analysis is required to capture worst-case.

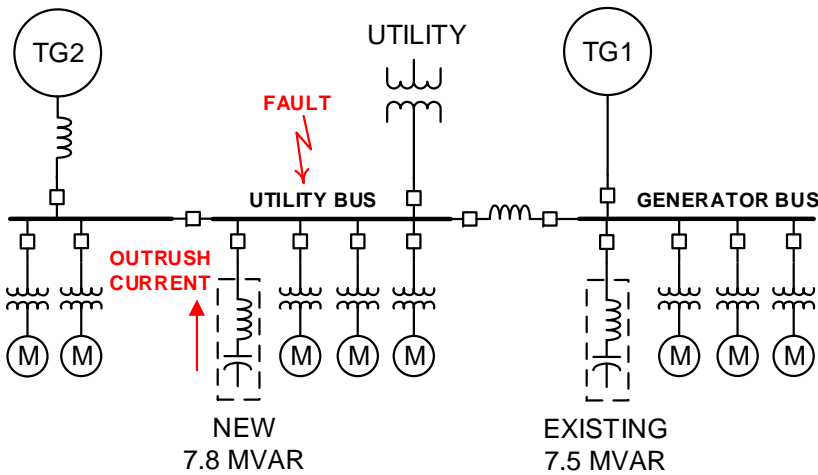
UTILITY BUS CAP BANK

Frequency of Outrush
Current is around 320 Hz

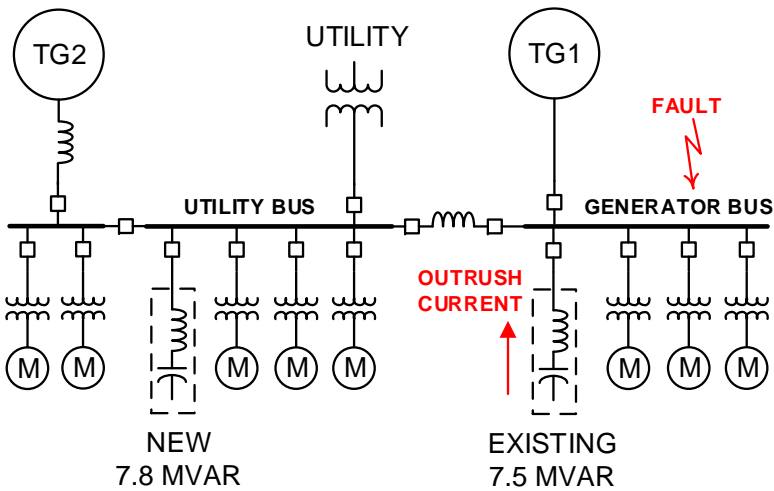
GENERATOR BUS CAP BANK

Frequency of Outrush
Current is around 270 Hz

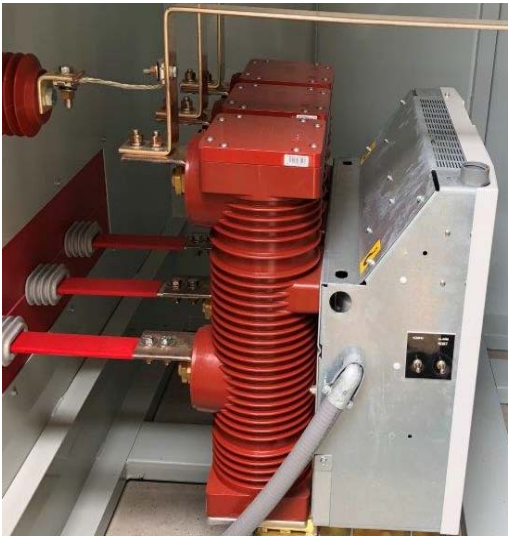
ABB DS1 Transient Free Capacitor Switch

A diode-based transient-free capacitor switch (TFCS) was incorporated into the new capacitor bank design.

The **ABB model DS1** synchronizes with the AC system to perform capacitor bank switching operations without disturbing the network.

- The concept of including a “zero crossing closure device” to switch the relatively large capacitor bank ON and OFF line proved extremely valuable. The switch options considered included conventional breaker, timed pole-closure breaker and diode insertion and the project team believes the **ABB DS-1** diode-based TFCS was the absolute best choice.

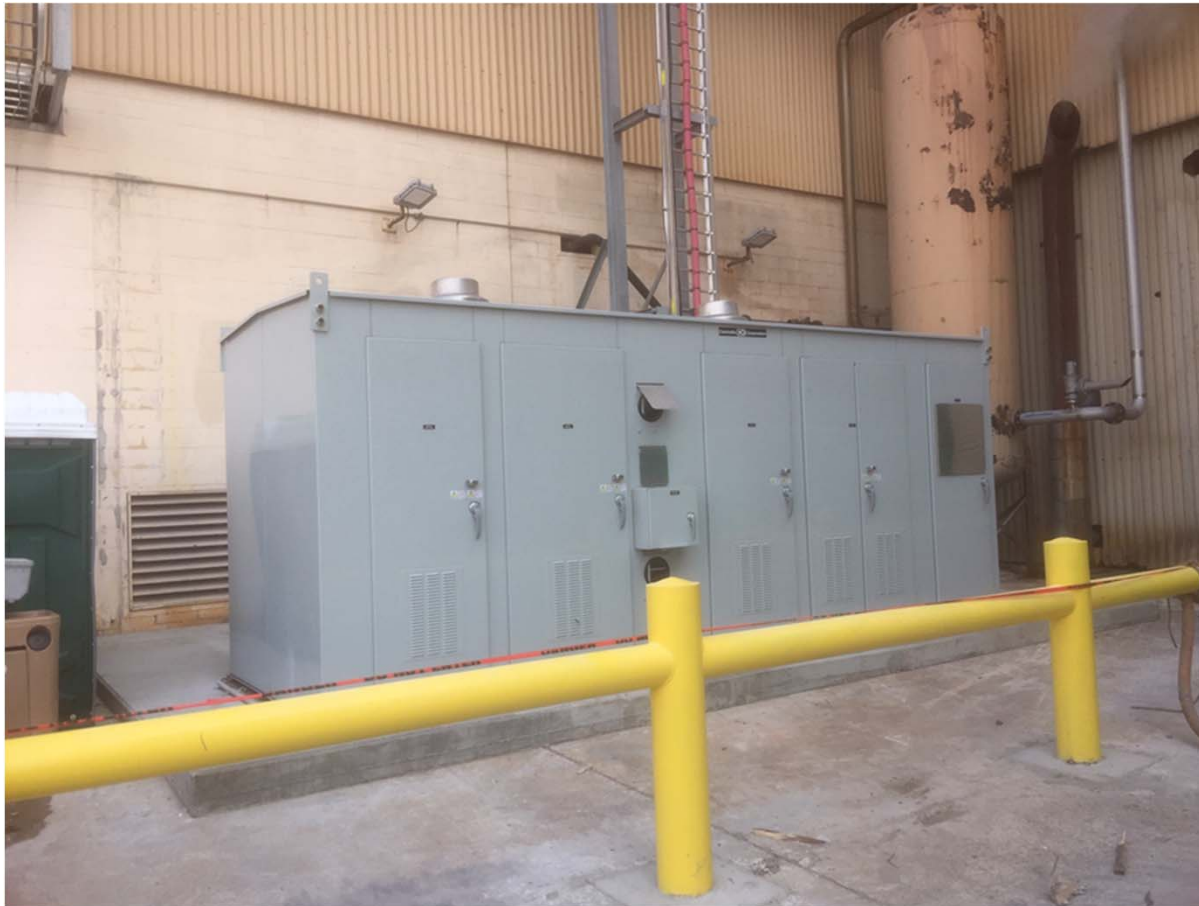
Capacitor Bank Deployment

A plan was developed to use three 3-phase power monitors to record voltages during switching.

Meter connected to the breaker on the Utility Bus that would connect to the input of the new capacitor bank.

Meter connected at the Generator Bus breaker which feeds the existing capacitor bank.

Meter connected to the 480V system that was deemed to be the most vulnerable, i.e. the supply to the pulp machine sectional and winder drives which are supplied from the Utility Bus, where the new capacitor bank was to be connected.

There was also a peak-reading clamp-on AC ammeter at the existing capacitor bank breaker in an effort to see any significant back-to-back current flow when the new capacitor was put on line.
